WO-LT-0057

Fire Suppression Systems Assessment at Tarakhil Thermal  
Power Plant – Final Report

June 26, 2012 Final

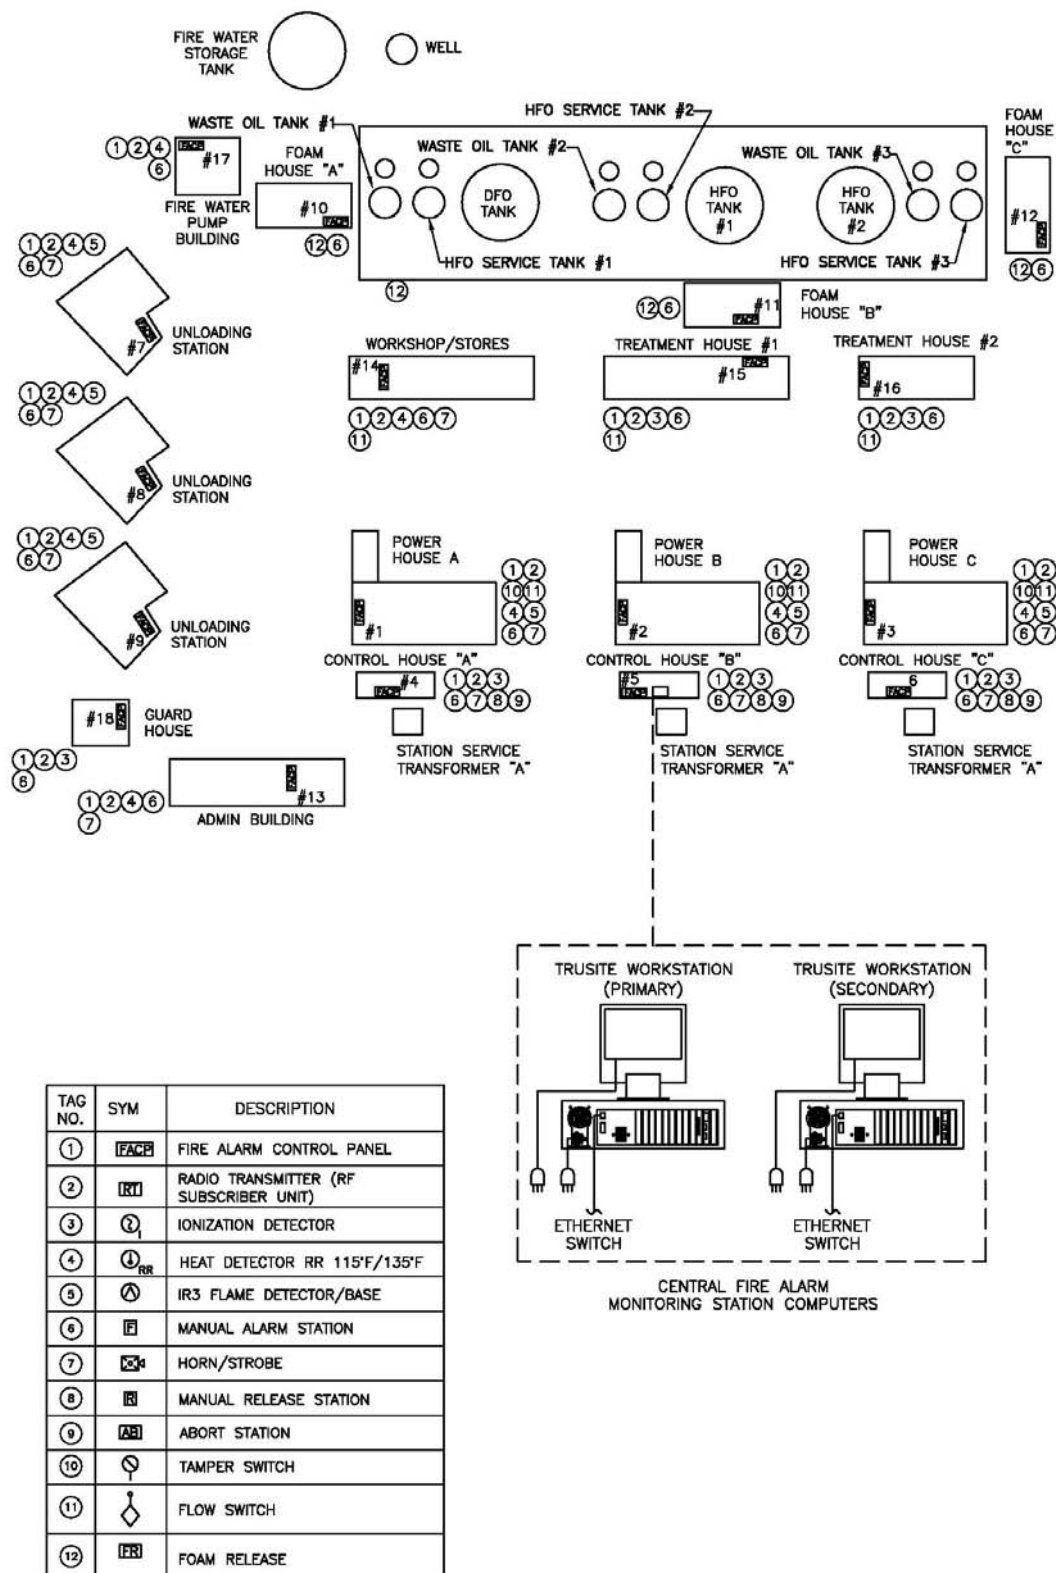
The Tarakhil TPP has a proprietary addressable fire detection and alarm system. Each building has a dedicated fire alarm control panel (FACP) (Simplex, Model 4100U) to monitor alarm initiation and supervisory devices in the building.

Figure 2: Fire Detection and Alarm System

In the event of a fire, manual alarm stations, sprinkler flow switches, heat, flame and ionization detectors, foam system or other fire protection systems will signal to the FACP (Photographs 28 thru 38). The fire alarm control panel will activate building notification devices which notify building employees. At the same time the FACP will signal the Radio Transmitter Panel (RF Subscriber Unit –AES IntelliNet, Model 7788F) to link the building's fire alarm control panel to the central fire alarm monitoring station located in Control Room B.

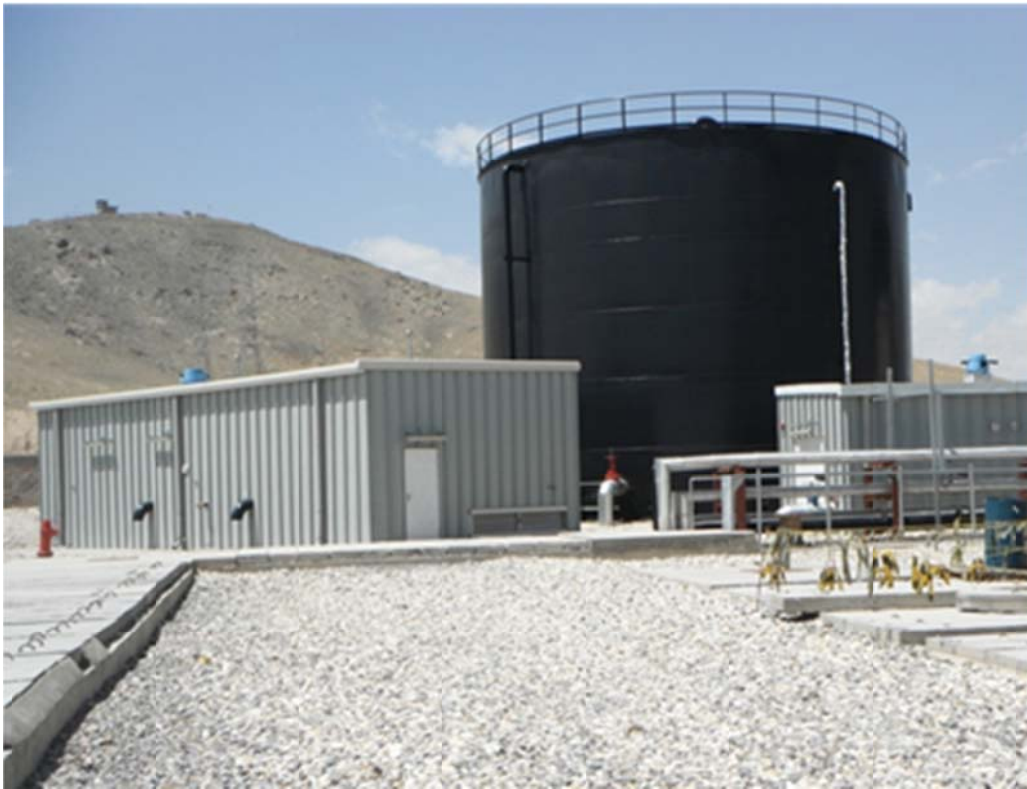
Photograph 1: Fire Pump House Building (foreground left), Fire Water Storage Tank

- The basis-of-design values that were used for the well pump and fire water storage tank sizing were not available. Based on the estimation detailed in the Analysis section, the well pump size is inadequate. It is recommended that additional well water production capacity be provided.

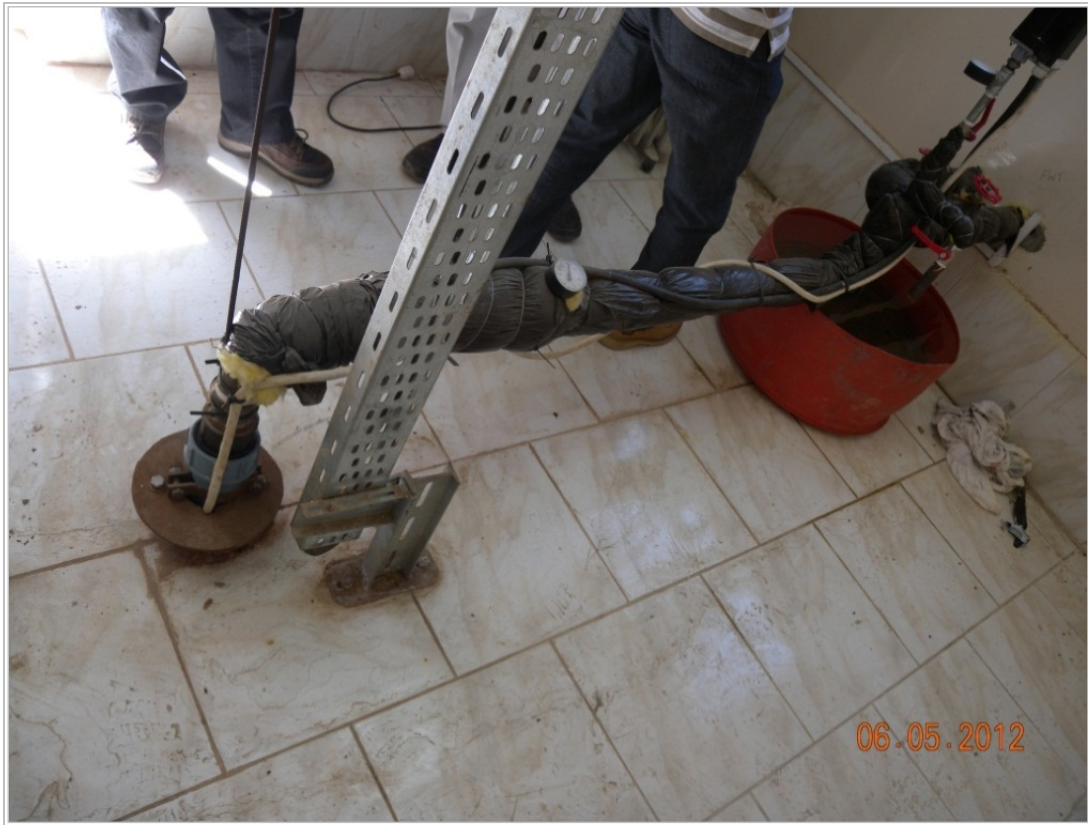
Photograph 3: Well Head Piping

3. The inspection team visited the Well House building to observe the pumping operations. The one (1) existing submersible well pump provides water for both the fire water storage tank and the site compound. Tt expressed concern that there is only one pump available. B&V stated that they have a spare pump available to replace the existing pump if required and could be installed in a couple of hours.

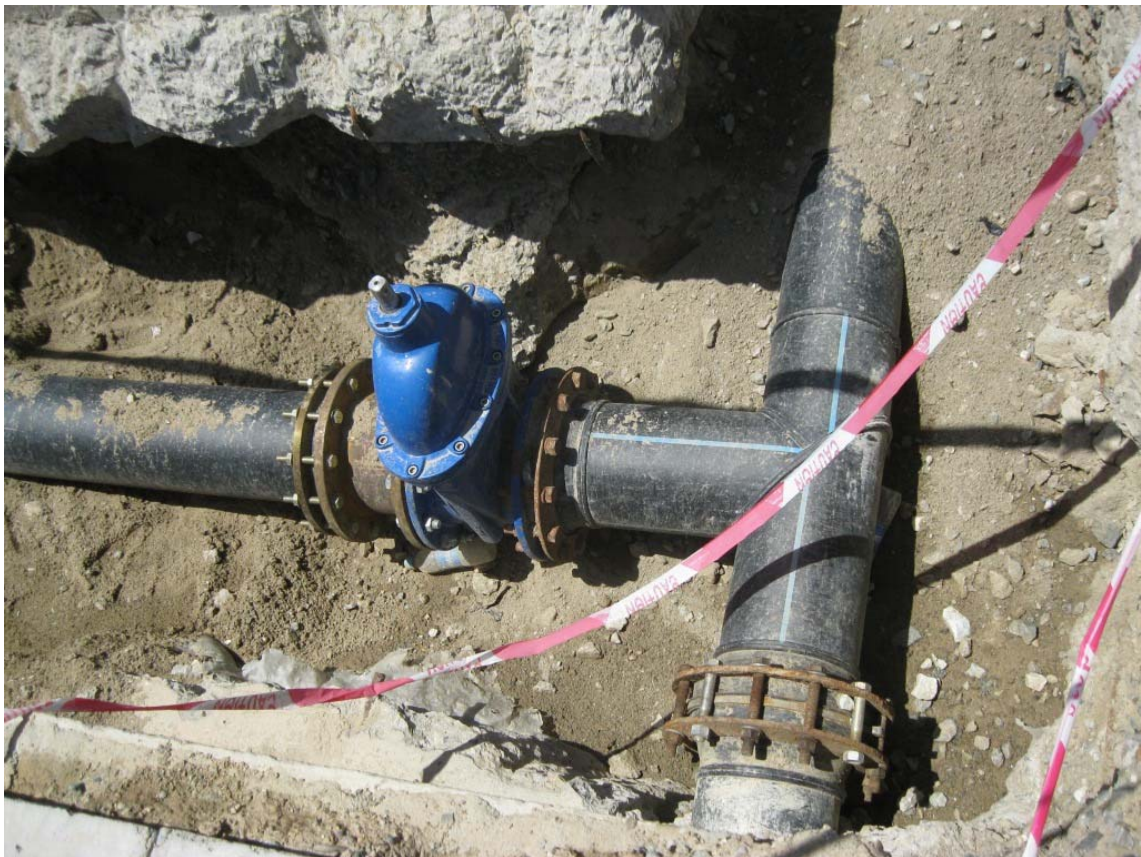
During the first site visit, [REDACTED] of B&V explained that because of leaks in the plant HDPE fire water distribution system only portions of the fire suppression system have been fully operational up to this time. B&V also stated that the leaking joints in the HDPE pipe have been repaired. One of the recent, belowground repair locations remained exposed, see Photograph 4.

Photograph 4: Exposed 250mm HDPE Underground Fire Water Line

- Two pressure tests were done on the HDPE underground fire protection pipe system that confirmed that the leaking problem has been resolved. There is no further action required.

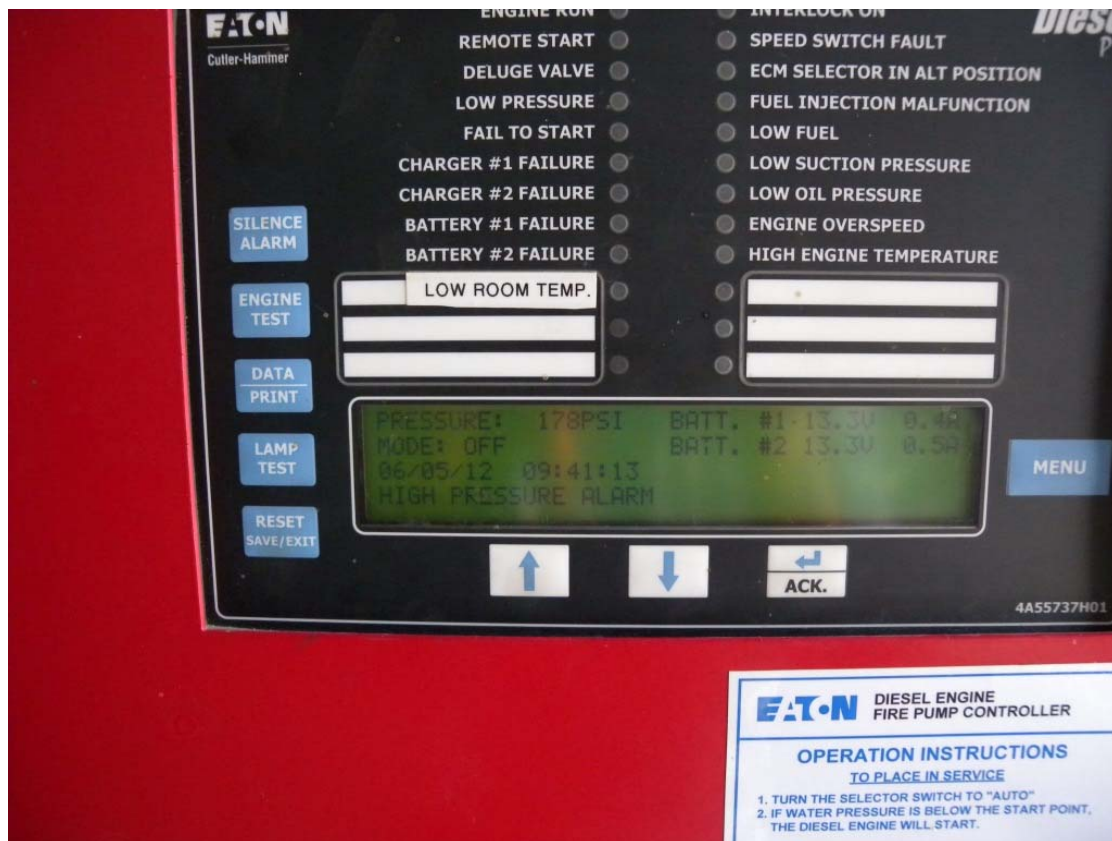
Photograph 7: Diesel Engine Fire Pump Controller Panel (at start of pressure test)

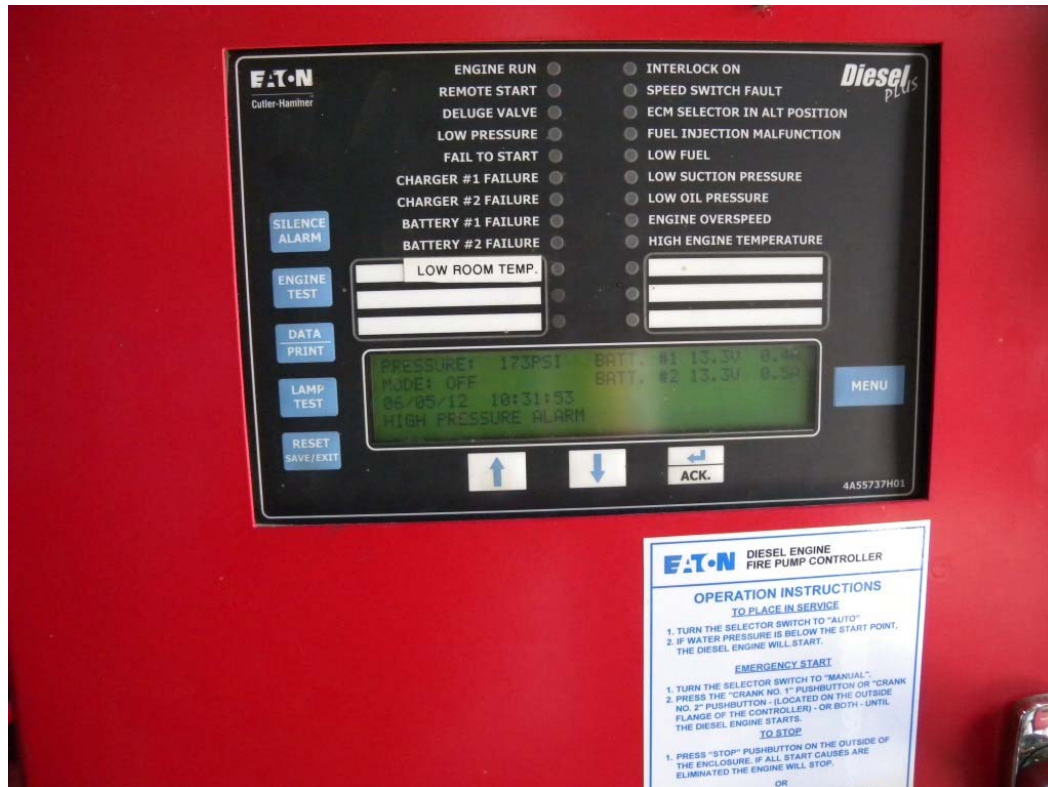
Photograph 8: Diesel Engine Fire Pump Controller Panel (at end of pressure test)

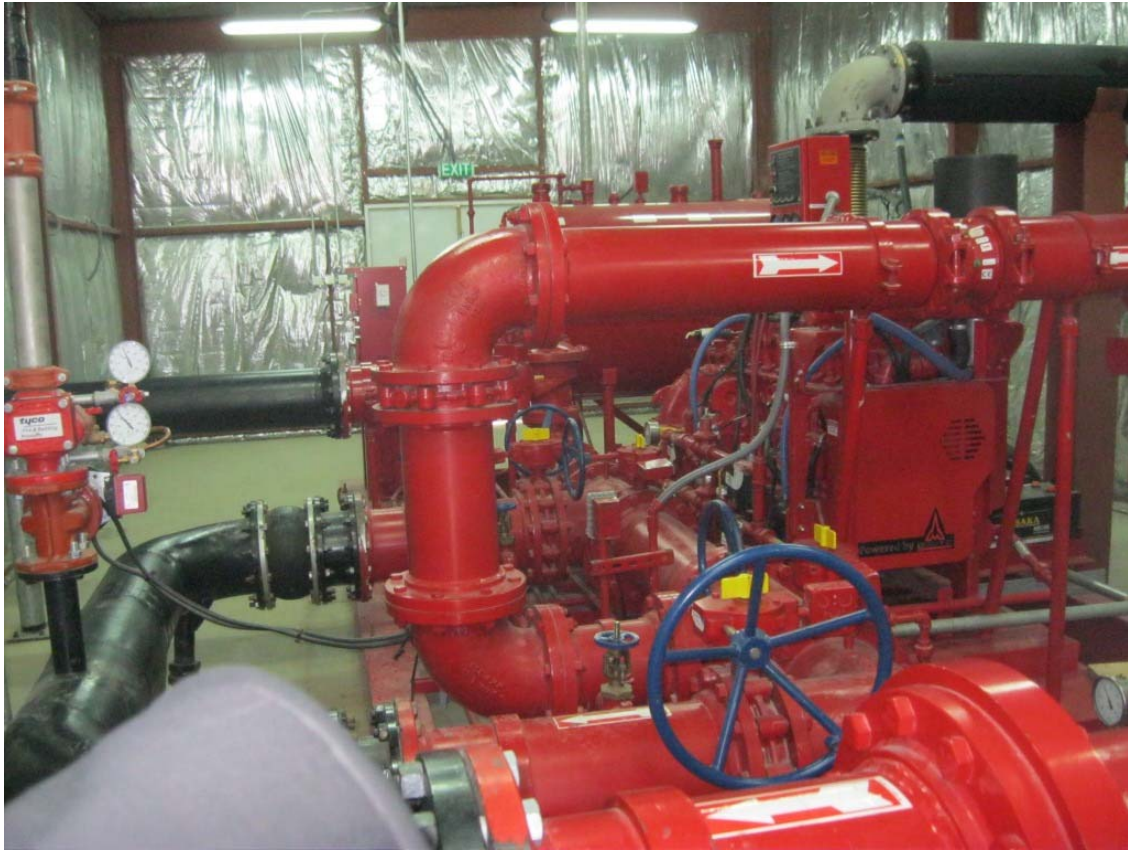
The Pump House equipment is “skid mounted” and enclosed in a prefabricated enclosure supplied by Simplex-USA, a division of Tyco Fire and Building Products. The three automatic/manual controlled pumps operate in series to provide the fire suppression system required pressure and volume demands. One pump is a 380 V, 3 Phase, 50 Hz, 95 liters/min (25 gpm), 12.5 bar (150 psi), 3.73 KW (5 hp) centrifugal “jockey pump.” The other two pumps are diesel engine driven 7,570 liters/min (2,000 gpm), 8.62 bar (125 psi), 186.43 KW (250 hp) horizontal centrifugal pumps. The Diesel Engine Fire Pump Controller panel provides automatic/manual control of the pumping system.

Photograph 9: Pump House Building (piping and pumps).

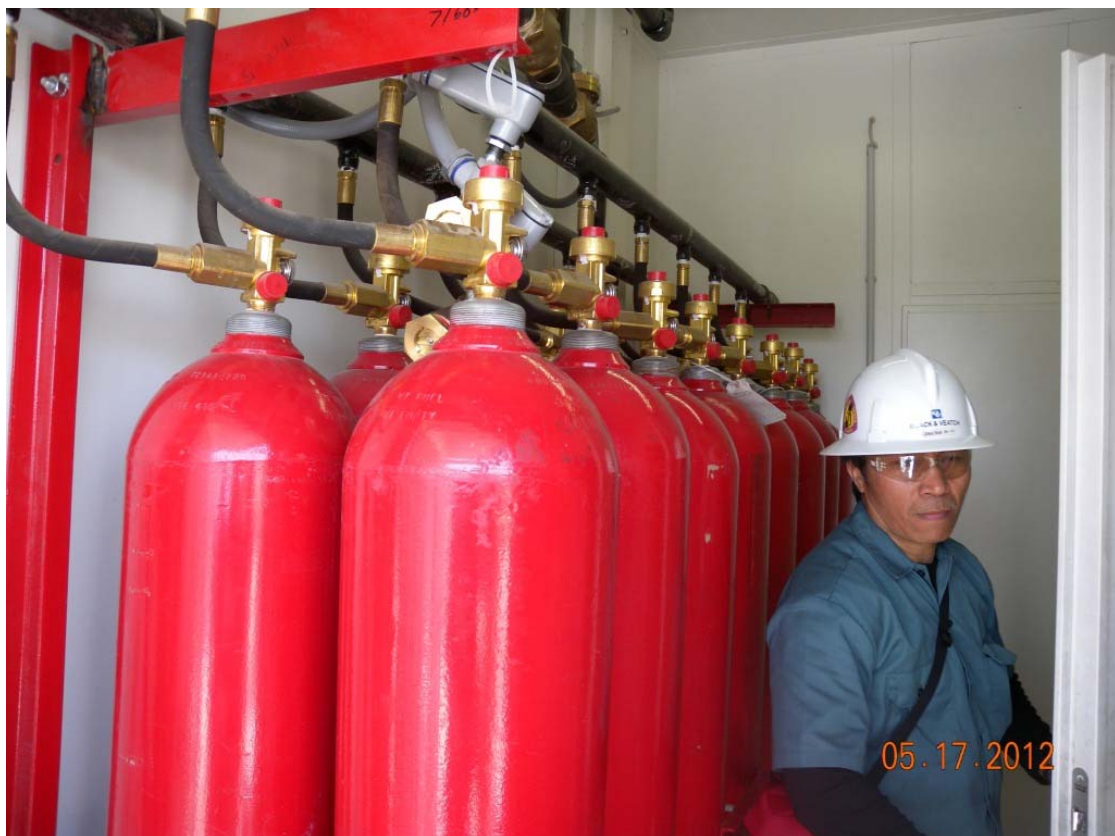
Another concern that USAID had identified was “a problem with one of the gas tanks” on the argon gas fire suppression systems in the three Control House buildings. During our first site assessment visit B&V stated that the tank problem has been resolved and the system is fully operational. The assessment team observed the condition of the argon gas system in Control House building B during the first site visit which seems complete and functional, although, the team did not find final testing documentation in documents collected for this report.

Photograph 16: Argon Gas Cylinders

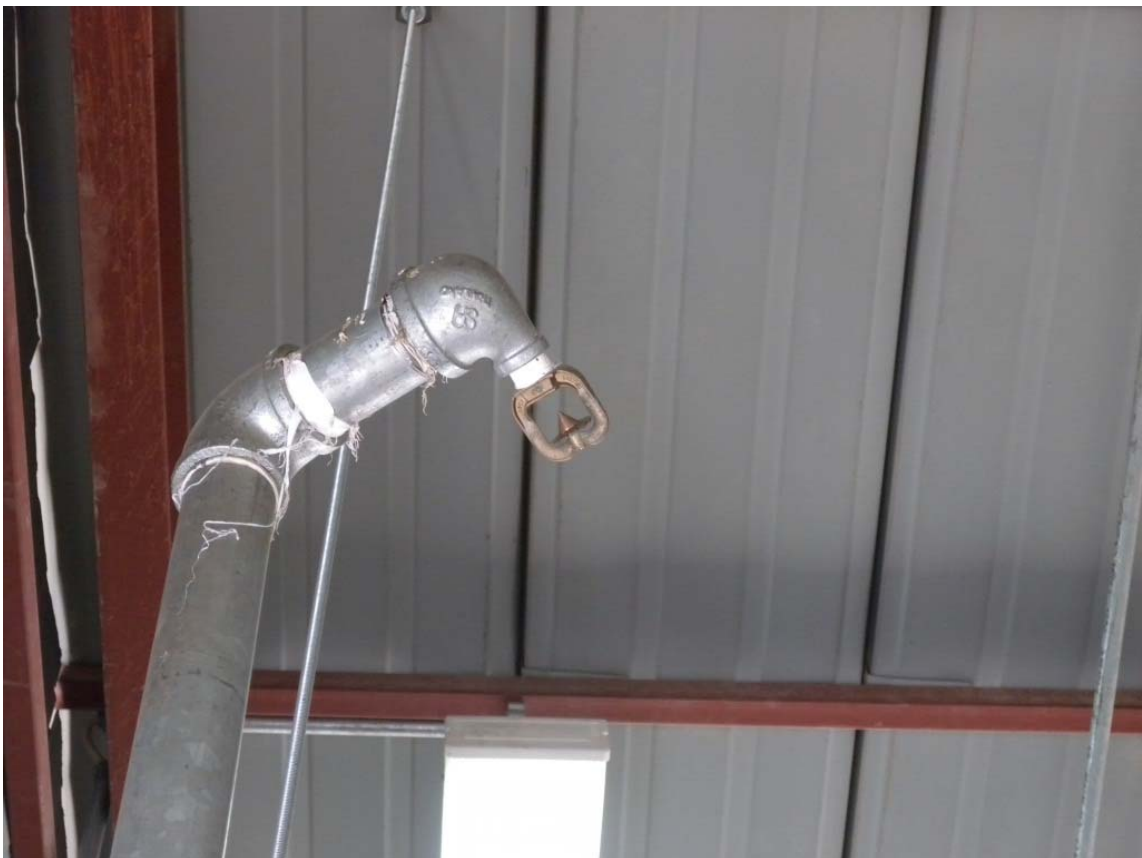
21. A “Dry-Type” fire protection system is used to protect the transformers. These transformers are located in three separate buildings adjacent to each of the three Power House Buildings. The systems are dry to prevent freezing. Air pressure closes a bladder separating the 125psi fire water line from the dry pipe. Under a fire condition, the air pressure is released and the dry line is flooded and discharged through a ceiling sprinkler system in the transformer rooms.

Photograph 18: Water Sprinkler Service Station Transformer Building

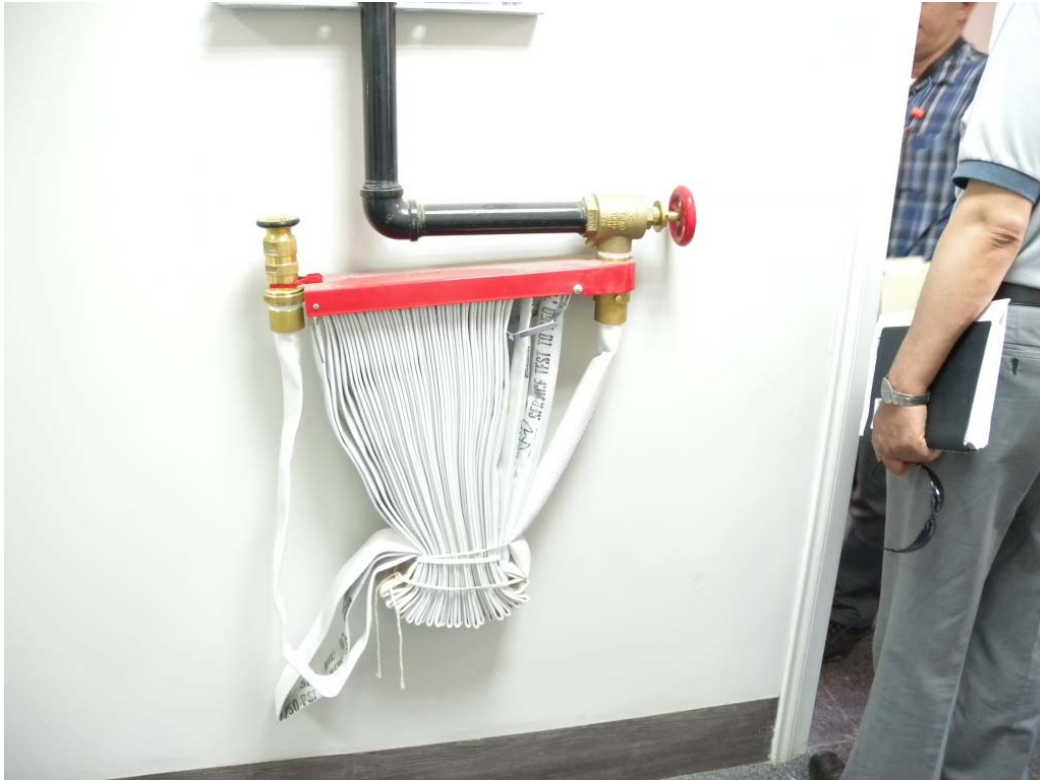
Photograph 19: Administration Building Hose Station

6. The Administration Building has no sprinkler system but has two hose stations.
  7. We visited the workshop building and observed the two hose stations and the portable fire suppression extinguishers.

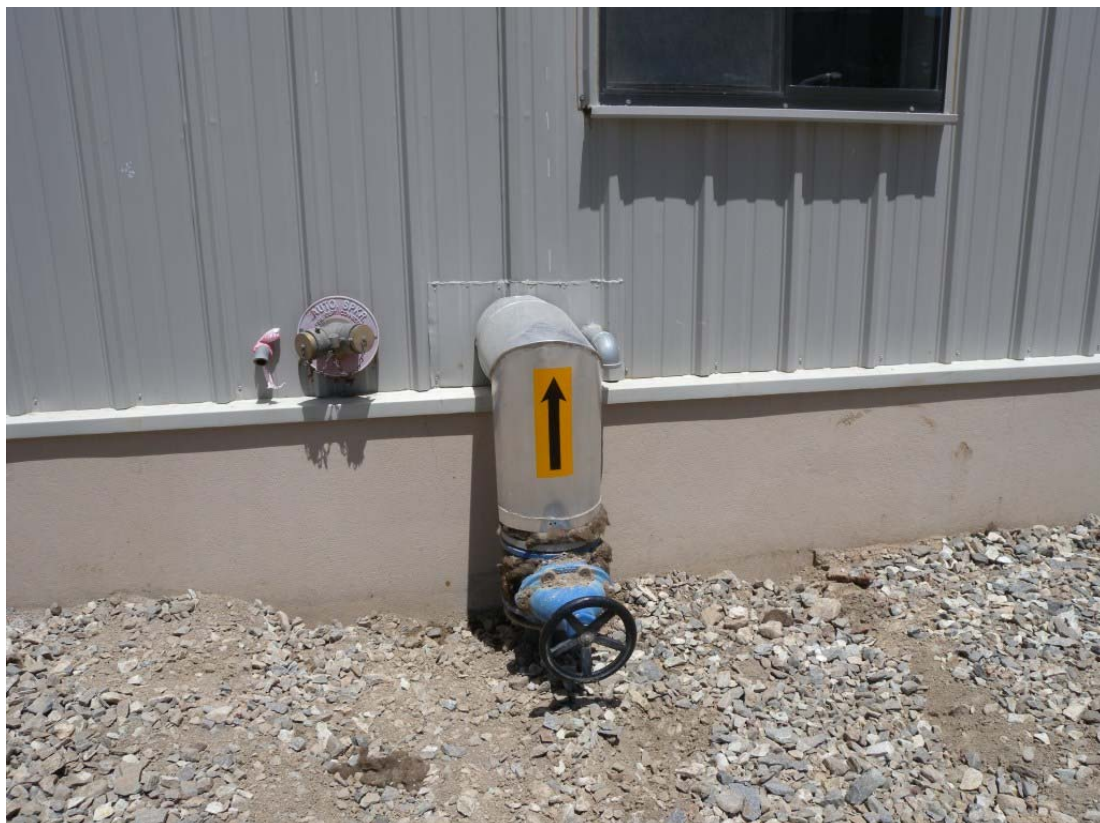
Photograph 22: Treatment House 1, 200mm Pipe Connection to Underground Fire Water Insulation and Gate Valve (Typical all buildings)

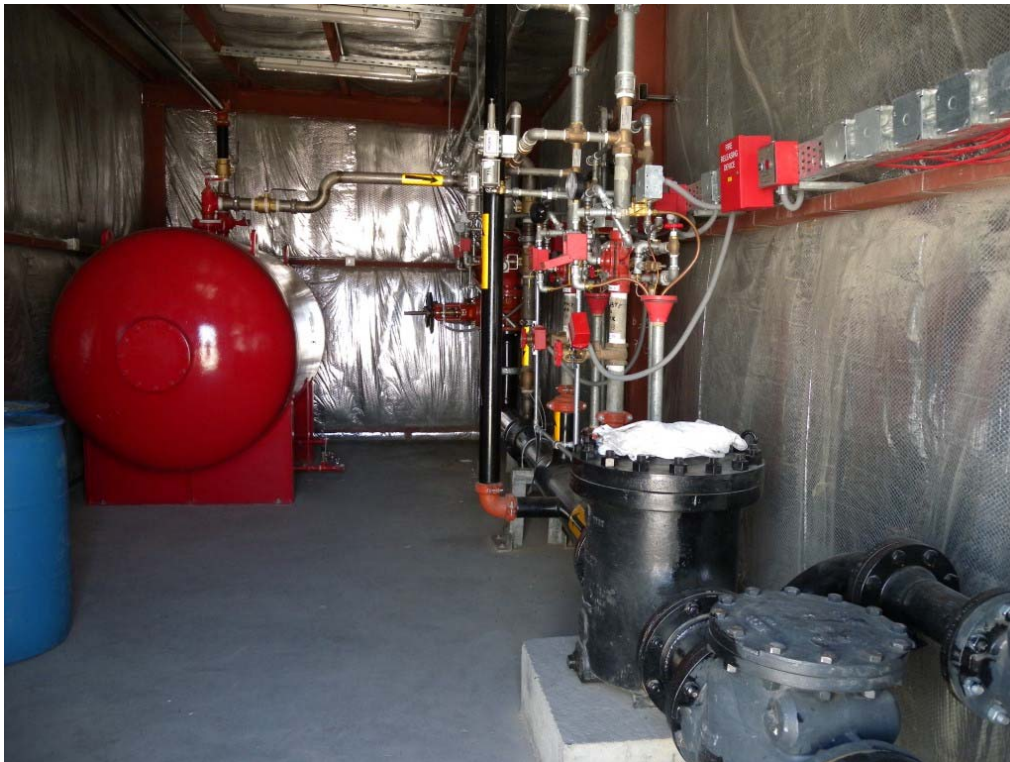
Photograph 24: Foam House Building B Bladder Foam Chemical Storage Tank and Piping  
(A and C similar)

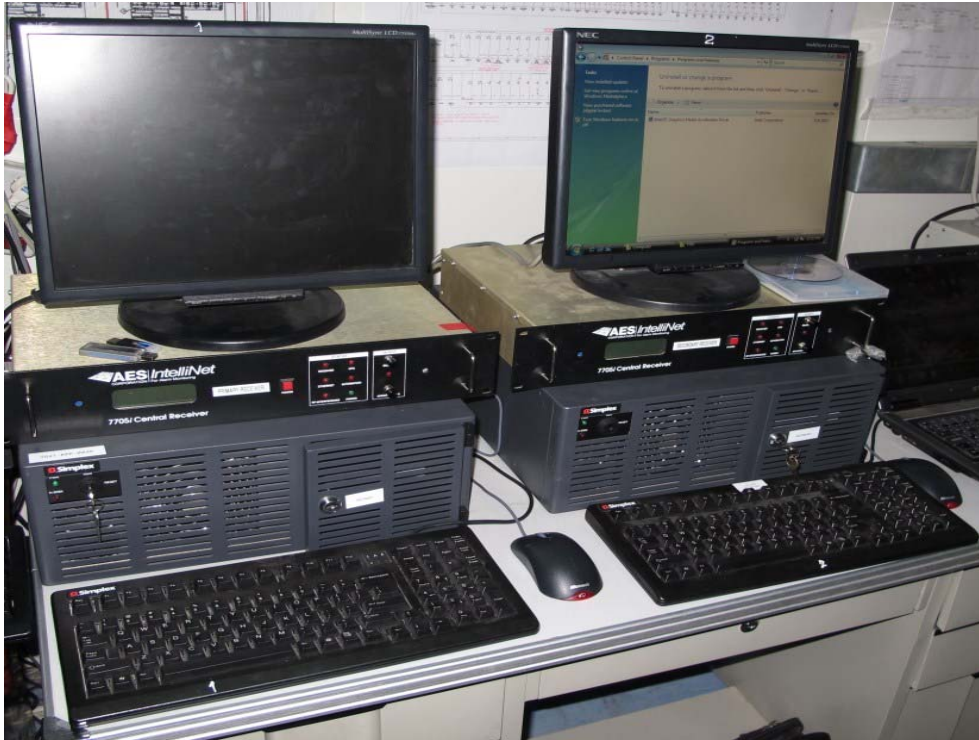
Concerns were reported to the USAID that the Central Fire Alarm monitoring station computers were not functioning. During the initial site visit on May 17, 2012, B&V confirmed to the assessment team that the computers that monitor fire alarm were out of service due to a power surge. B&V had scheduled a Simplex technician from Turkey to be on site Friday May 18, 2012 to install new monitors and computers and check the Simplex-USA system settings, establish appurtenant links and replace any defective parts of the monitoring system.

During the second site visit on June 5, 2012 the Simplex technician was working on the AES IntelliNet 7705 type Central Receiver's software programming to complete the Central Fire Alarm Monitoring Station repairs. To document repairs, B&V agreed to submit to USAID

and Tt assessment team, a screen shot of the monitor (image) during the alarm and test reports after the system repairs have been completed and the system is working properly.

Photograph 28: Central Fire Alarm Monitoring Station Computers

- The fire detection and alarm system is in good working order now. To keep the system running without any interruption, it is recommended that critical fire detection system devices proposed by Simplex be kept in on-site inventory to prevent long delays when repairs are necessary. Replacement of broken devices and reprogramming the entire system scheduled through a local fire alarm company familiar with Simplex fire detection and alarm system is recommended. The local fire alarm company can respond, as required monthly, quarterly or semiannually to provide testing.

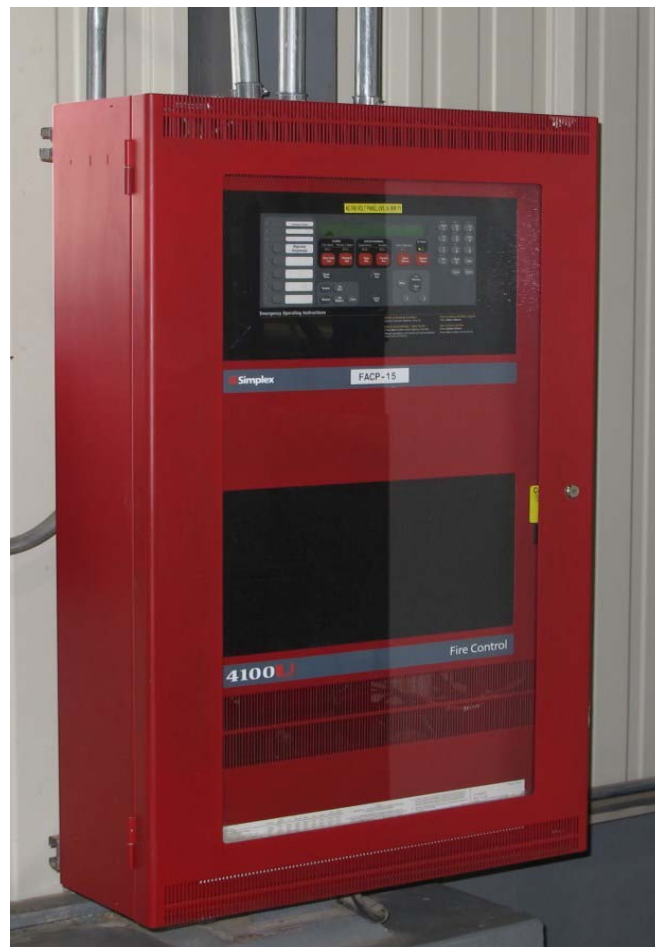
Photograph 29: Fire Alarm Control Panel

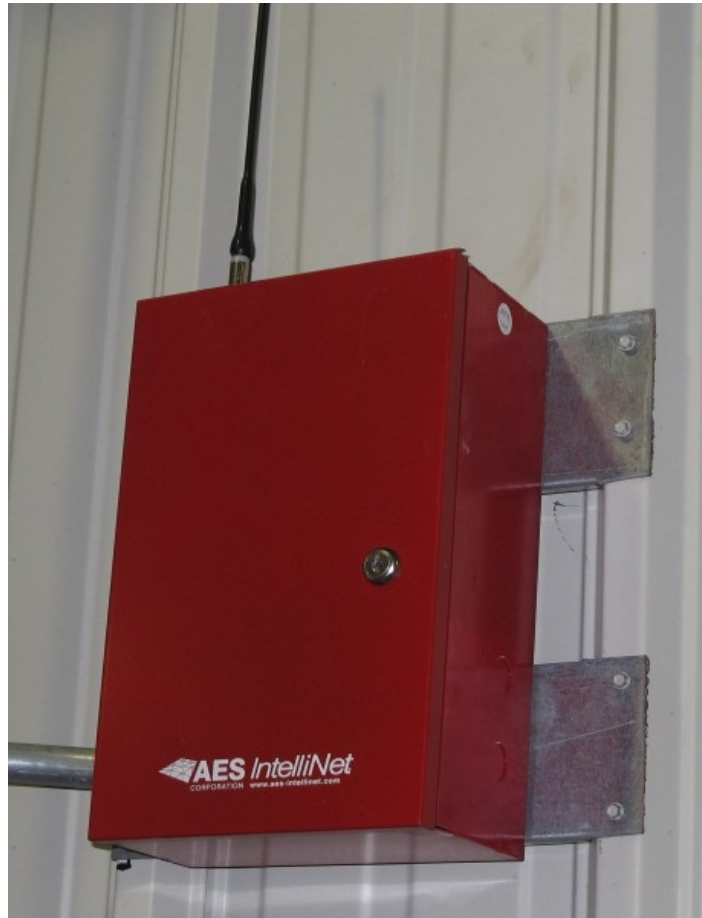
30: Radio Transmitter
